**DEPARTMENT OF TRANSPORTATION**

Contract #: 04-0120F4Cty: SF/Ala Rte: 80 PM: 13.2/13.9File #: 69.28**WELDING INSPECTION REPORT****Resident Engineer:** Pursell, Gary**Address:** 333 Burma Road**City:** Oakland, CA 94607**Report No:** WIR-015872**Date Inspected:** 24-Jul-2010**Project Name:** SAS Superstructure**OSM Arrival Time:** 1900**Prime Contractor:** American Bridge/Fluor Enterprises, a JV**OSM Departure Time:** 700**Contractor:** Zhenhua Port Machinery Company, Ltd (ZPMC), Changxing Island **Location:** Shanghai, China**CWI Name:** See below**CWI Present:** Yes No**Inspected CWI report:** Yes No N/A**Rod Oven in Use:** Yes No N/A**Electrode to specification:** Yes No N/A**Weld Procedures Followed:** Yes No N/A**Qualified Welders:** Yes No N/A**Verified Joint Fit-up:** Yes No N/A**Approved Drawings:** Yes No N/A**Approved WPS:** Yes No N/A**Delayed / Cancelled:** Yes No N/A**Bridge No:** 34-0006**Component:** Tower and OBG Components**Summary of Items Observed:**

## WELDING INSPECTION REPORT

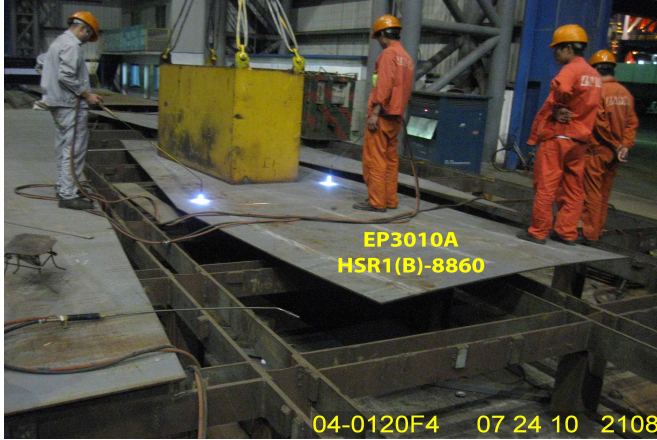
Heat straightening of PCMK OBG lift 13, side plate SP3110A. QC was identified as ZPMC CWI Liu Yang (QC1).

Assisting QC1 at this location and appearing to be monitoring the welding and recording data was ZPMC QC Yuan Hui Gang (QCA1), who was not a CWI. Heat treatment observed by this QA Inspector and recorded by QCA1 appeared to comply with HSR1(B)8860 presented to this QA Inspector by QCA1. See photo below.
